Manhole Inspection Summary

Manhole # S5100_009MH

Insp Date: **3/17/08 11:43 AM**

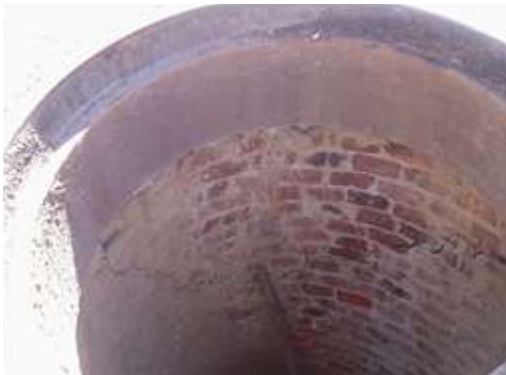
Defect 2

☒ **Leaks**

Frame Leaks

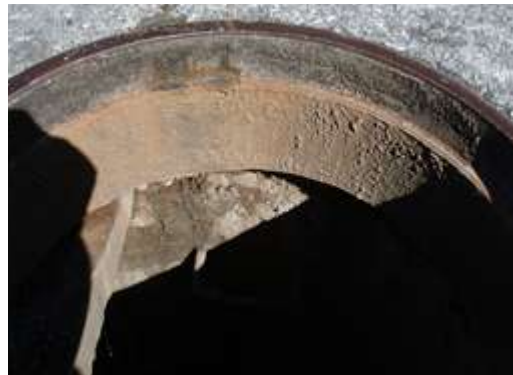
Defect 1

Adjustment Joint

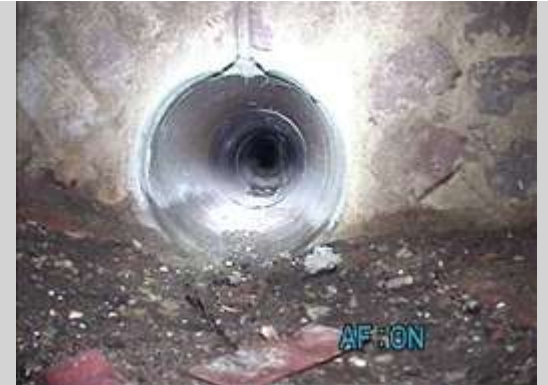
12 O'Clock Outflow

8 in. Circular Gravity Sewer
Pipe Out @ 12 O'Clock
